TS-PIC- 90783/91783
November 1990

AERIAL PHOTOGRAPHIC ANALYSIS OF SHELL CHEMICAL - DEER PARK MANUFACTURING COMPLEX

Deer Park, Texas

EPA Region 6

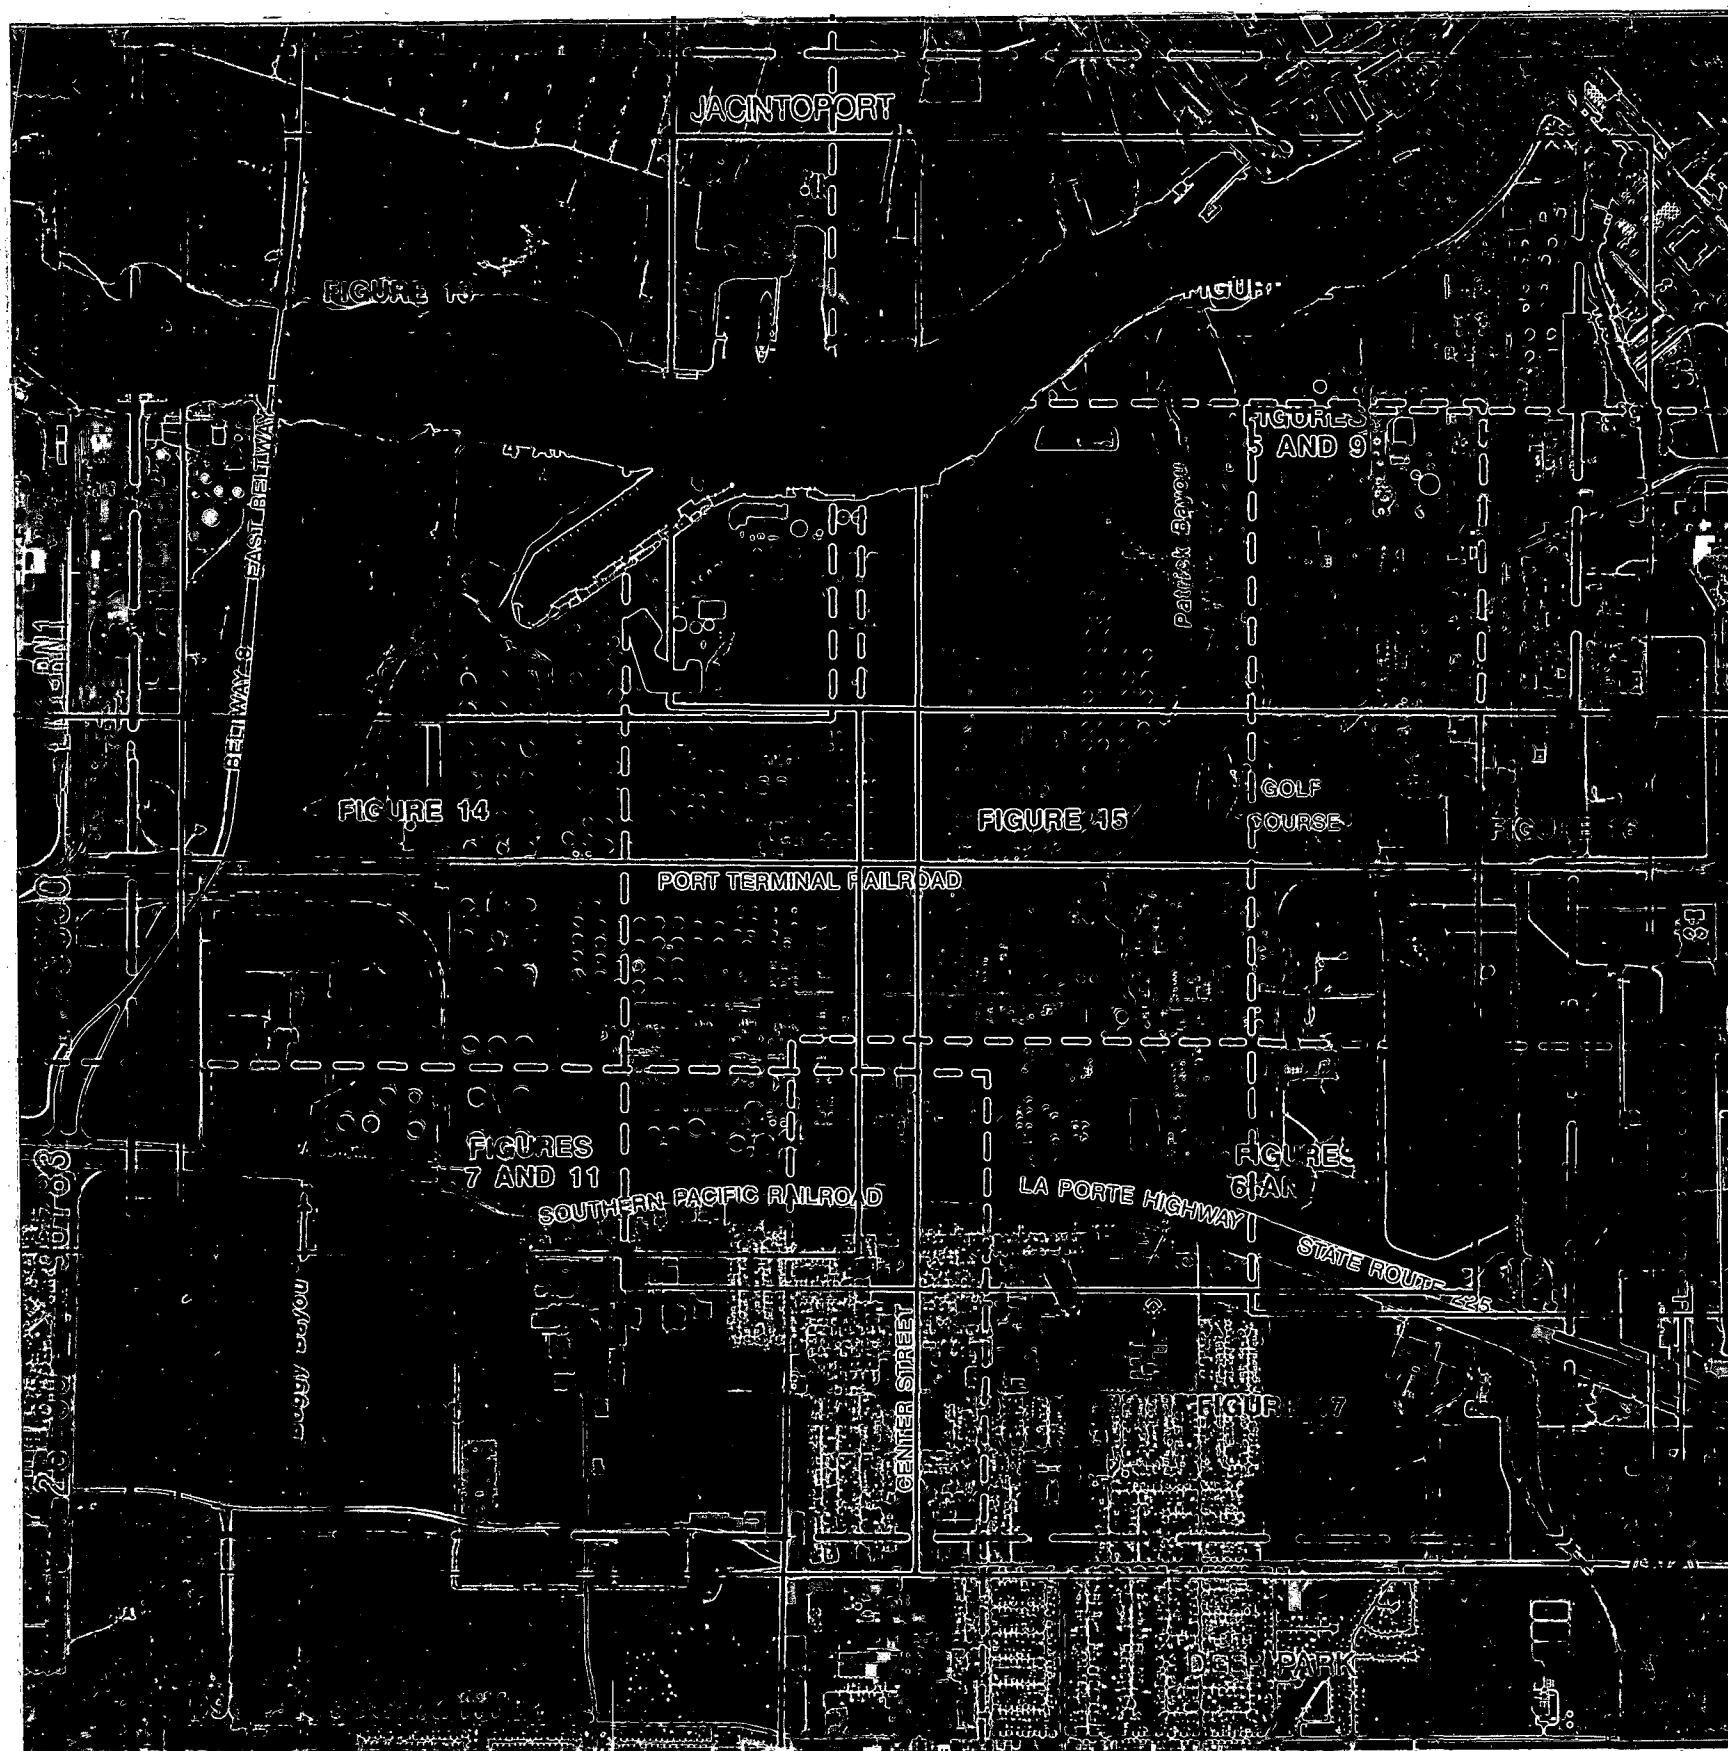
Figure 3. Shell Chemical-Deer Park Manufacturing Complex, August 26, 1990.
Approximate scale 1:25,500.

This conventional color photograph shows the study area in relation to the surrounding area. Shown on the overlays are the photo coverage indices, showing the approximate extent of the photographs used in this report.

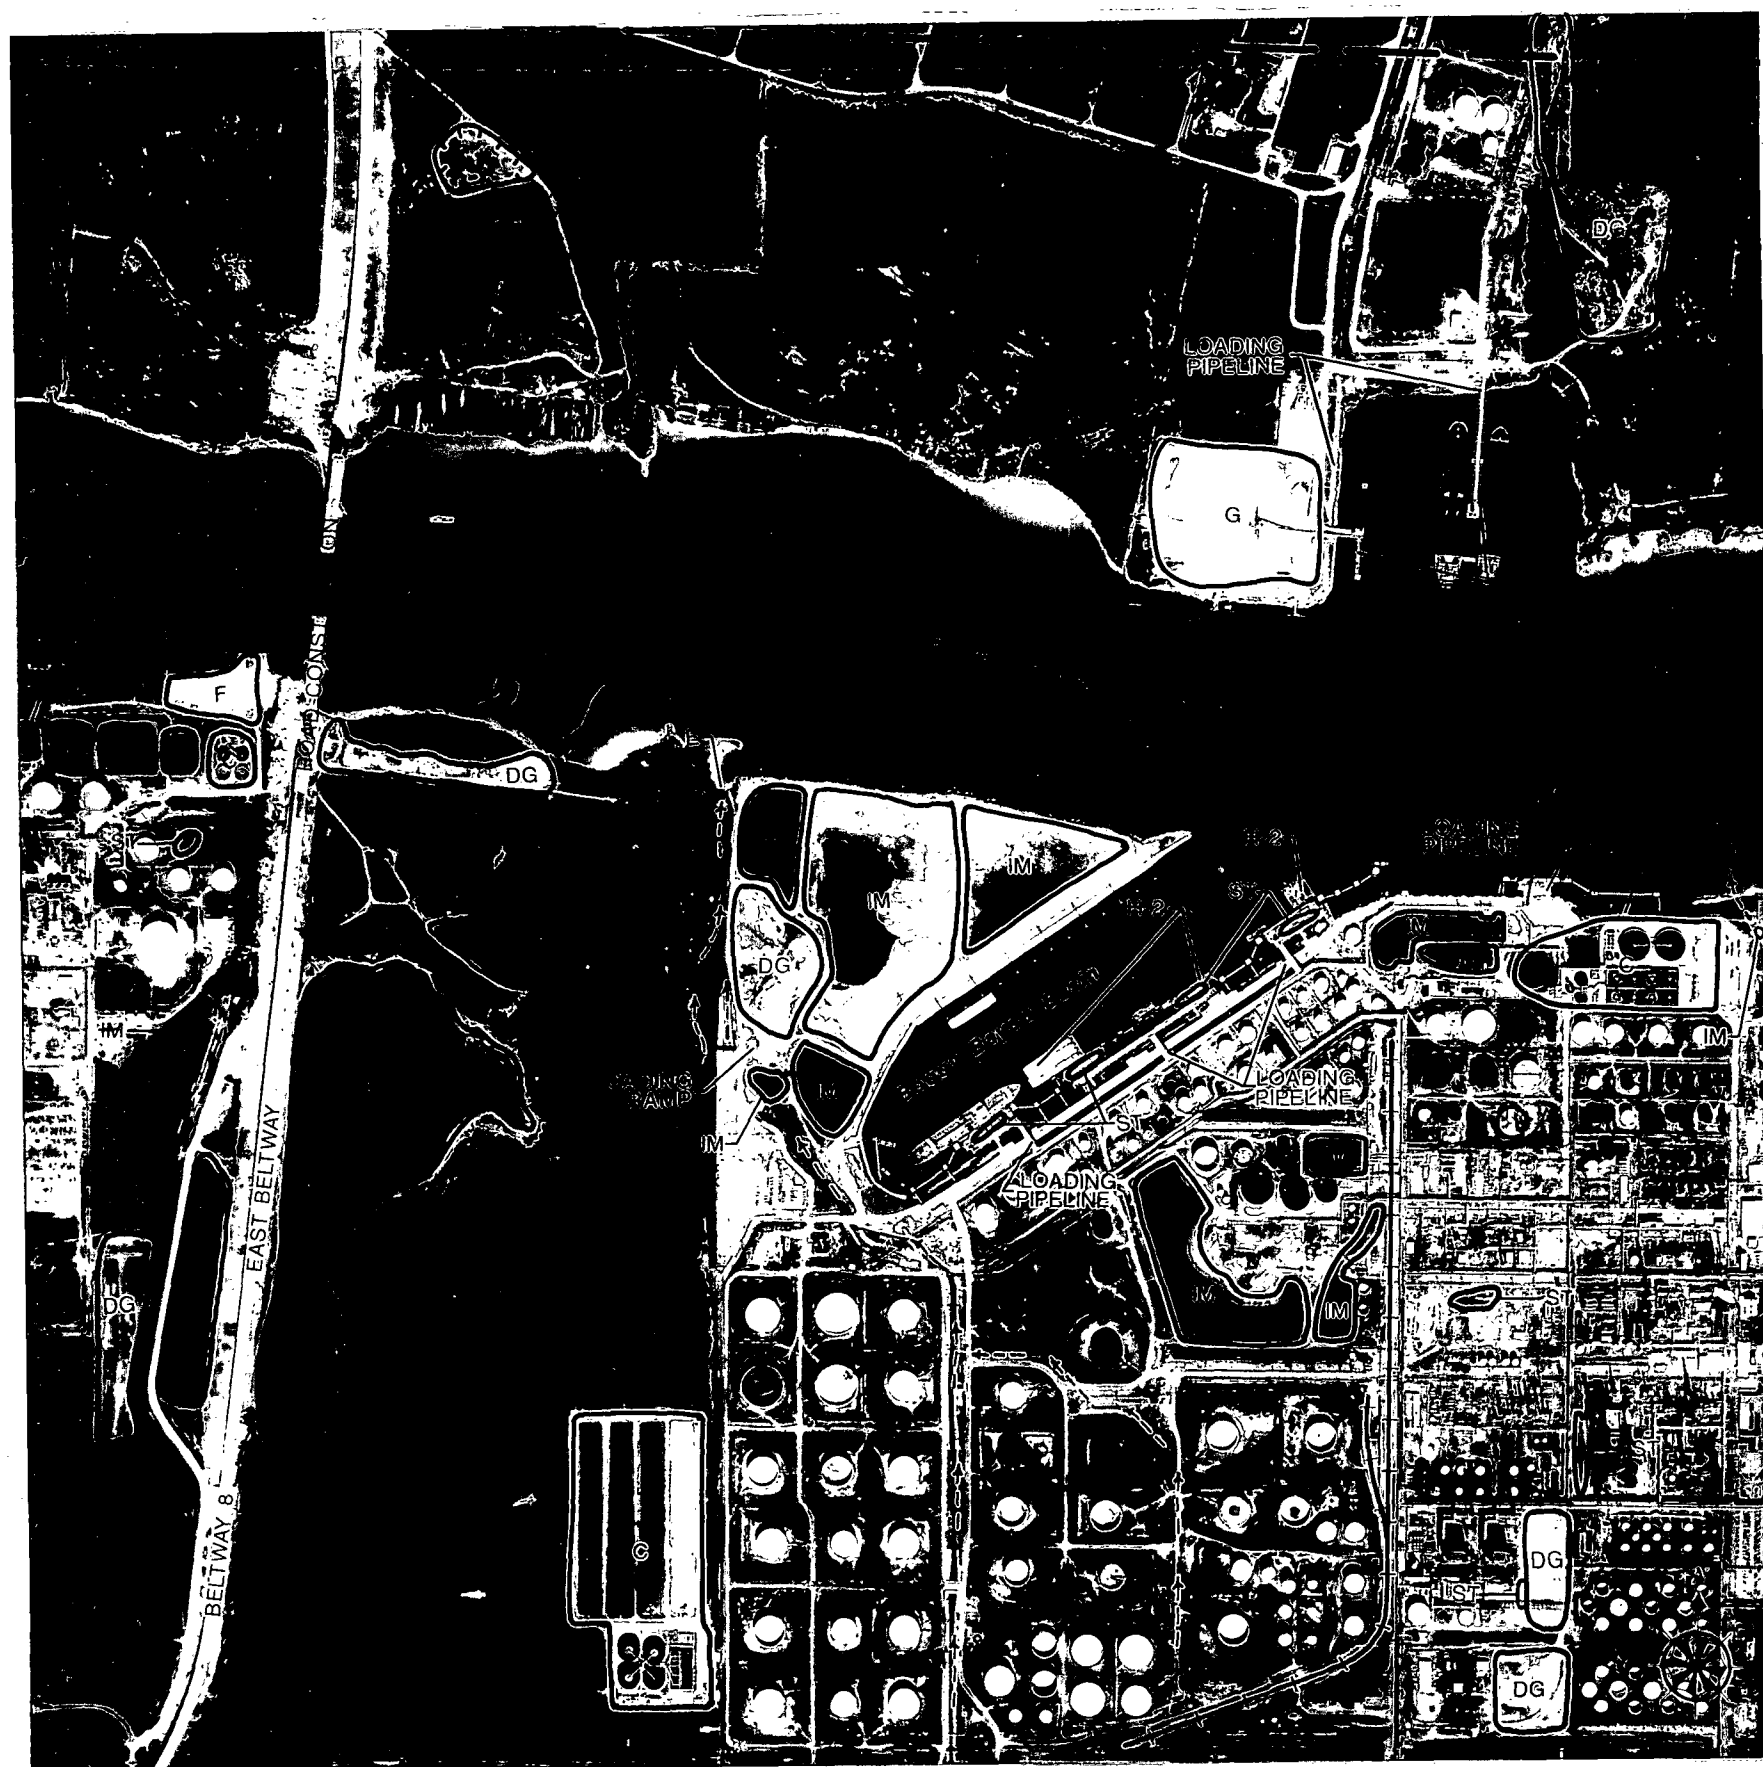
Figure 4. Shell Chemical-Deer Park Manufacturing Complex, November 4, 1981.
Approximate scale 1:11,000.

This photo covers the northwest quadrant of the study area. In this area all the storage tanks are adequately contained by berms. Several areas of staining are visible. There are 19 liquid impoundments visible in this photo. Six areas have been noted as ground disturbances. The East Beltway 8 is under construction in the western half of the photo. Other significant features are described below.

Annotation	Description
C	This annotation denotes a water treatment facility, there are three noted on the photo.
E	These are locations where an outfall is emptying into another drainage.
F	This is a possible waste disposal area.
G	This is a sand and gravel operation.
H-2	This ship loading/unloading facility handles petroleum coke, crude oil, petroleum products, and chemicals.
H-3	This ship loading/unloading facility handles petroleum coke, crude oil, petroleum products, vegetable oils, tallow, animal fats, sand, gravel, stone, cement, phosphate rock and aragonite.

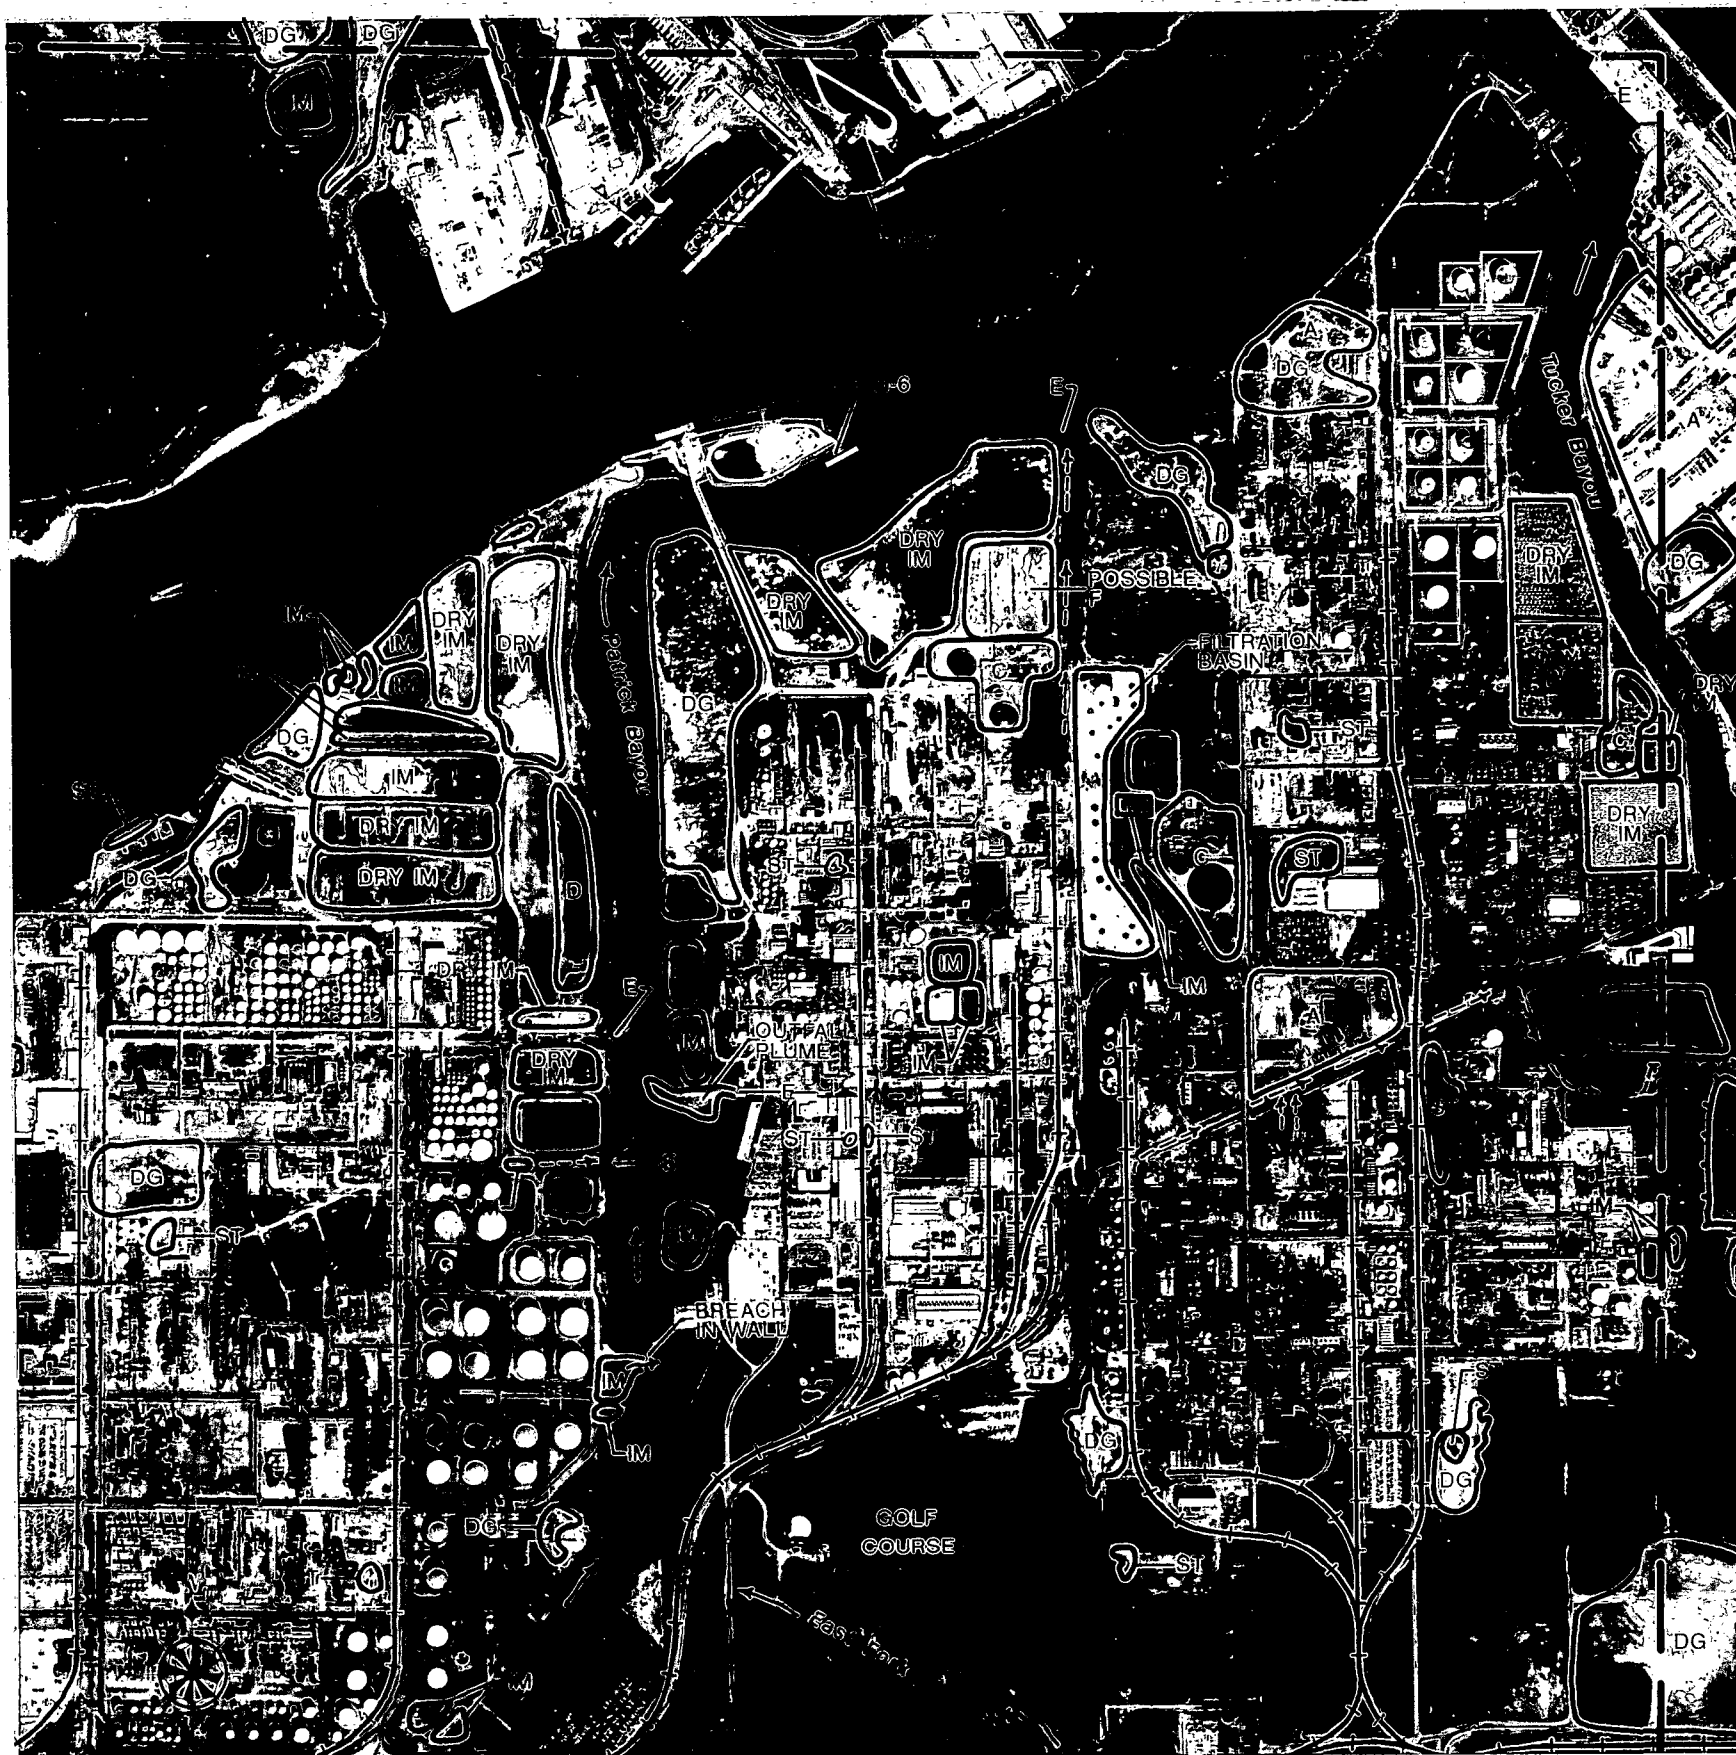
Figure 5. Shell Chemical-Deer Park Manufacturing Complex, November 4, 1981.
Approximate scale 1:11,000.

This photo covers the northeast quadrant of the study area. The storage tanks in this photo all have adequate containment. Several areas of staining are noted on the photo. Forty-three liquid impoundments are visible on this photo. Thirteen areas have been noted as ground disturbances. Several areas of mounded material are noted. Of special interest is the large outfall plume going into Patrick Bayou, and the liquid impoundment with a breached wall that also emptied into Patrick Bayou. Other significant features are described below.

Annotation	Description
A	Three storage areas containing various equipment for the facility, and also some stains and ground disturbances.
C	Three water treatment facilities are visible on this photo.
D	These are areas where dumping of waste or refuse is occurring.
E	Six areas of outfall have been noted on this photo.
F	This is a possible waste disposal area.
H-5	This ship loading/unloading facility handles containerized cargo, heavy material and equipment.
H-6	This ship loading/unloading facility handles heavy materials and equipment, chemicals, and petrochemicals.
H-7	This ship loading/unloading facility handles molasses, fertilizer, grain, and bulk cement.
H-9	This ship loading/unloading facility handles steel and fabricated steel products.

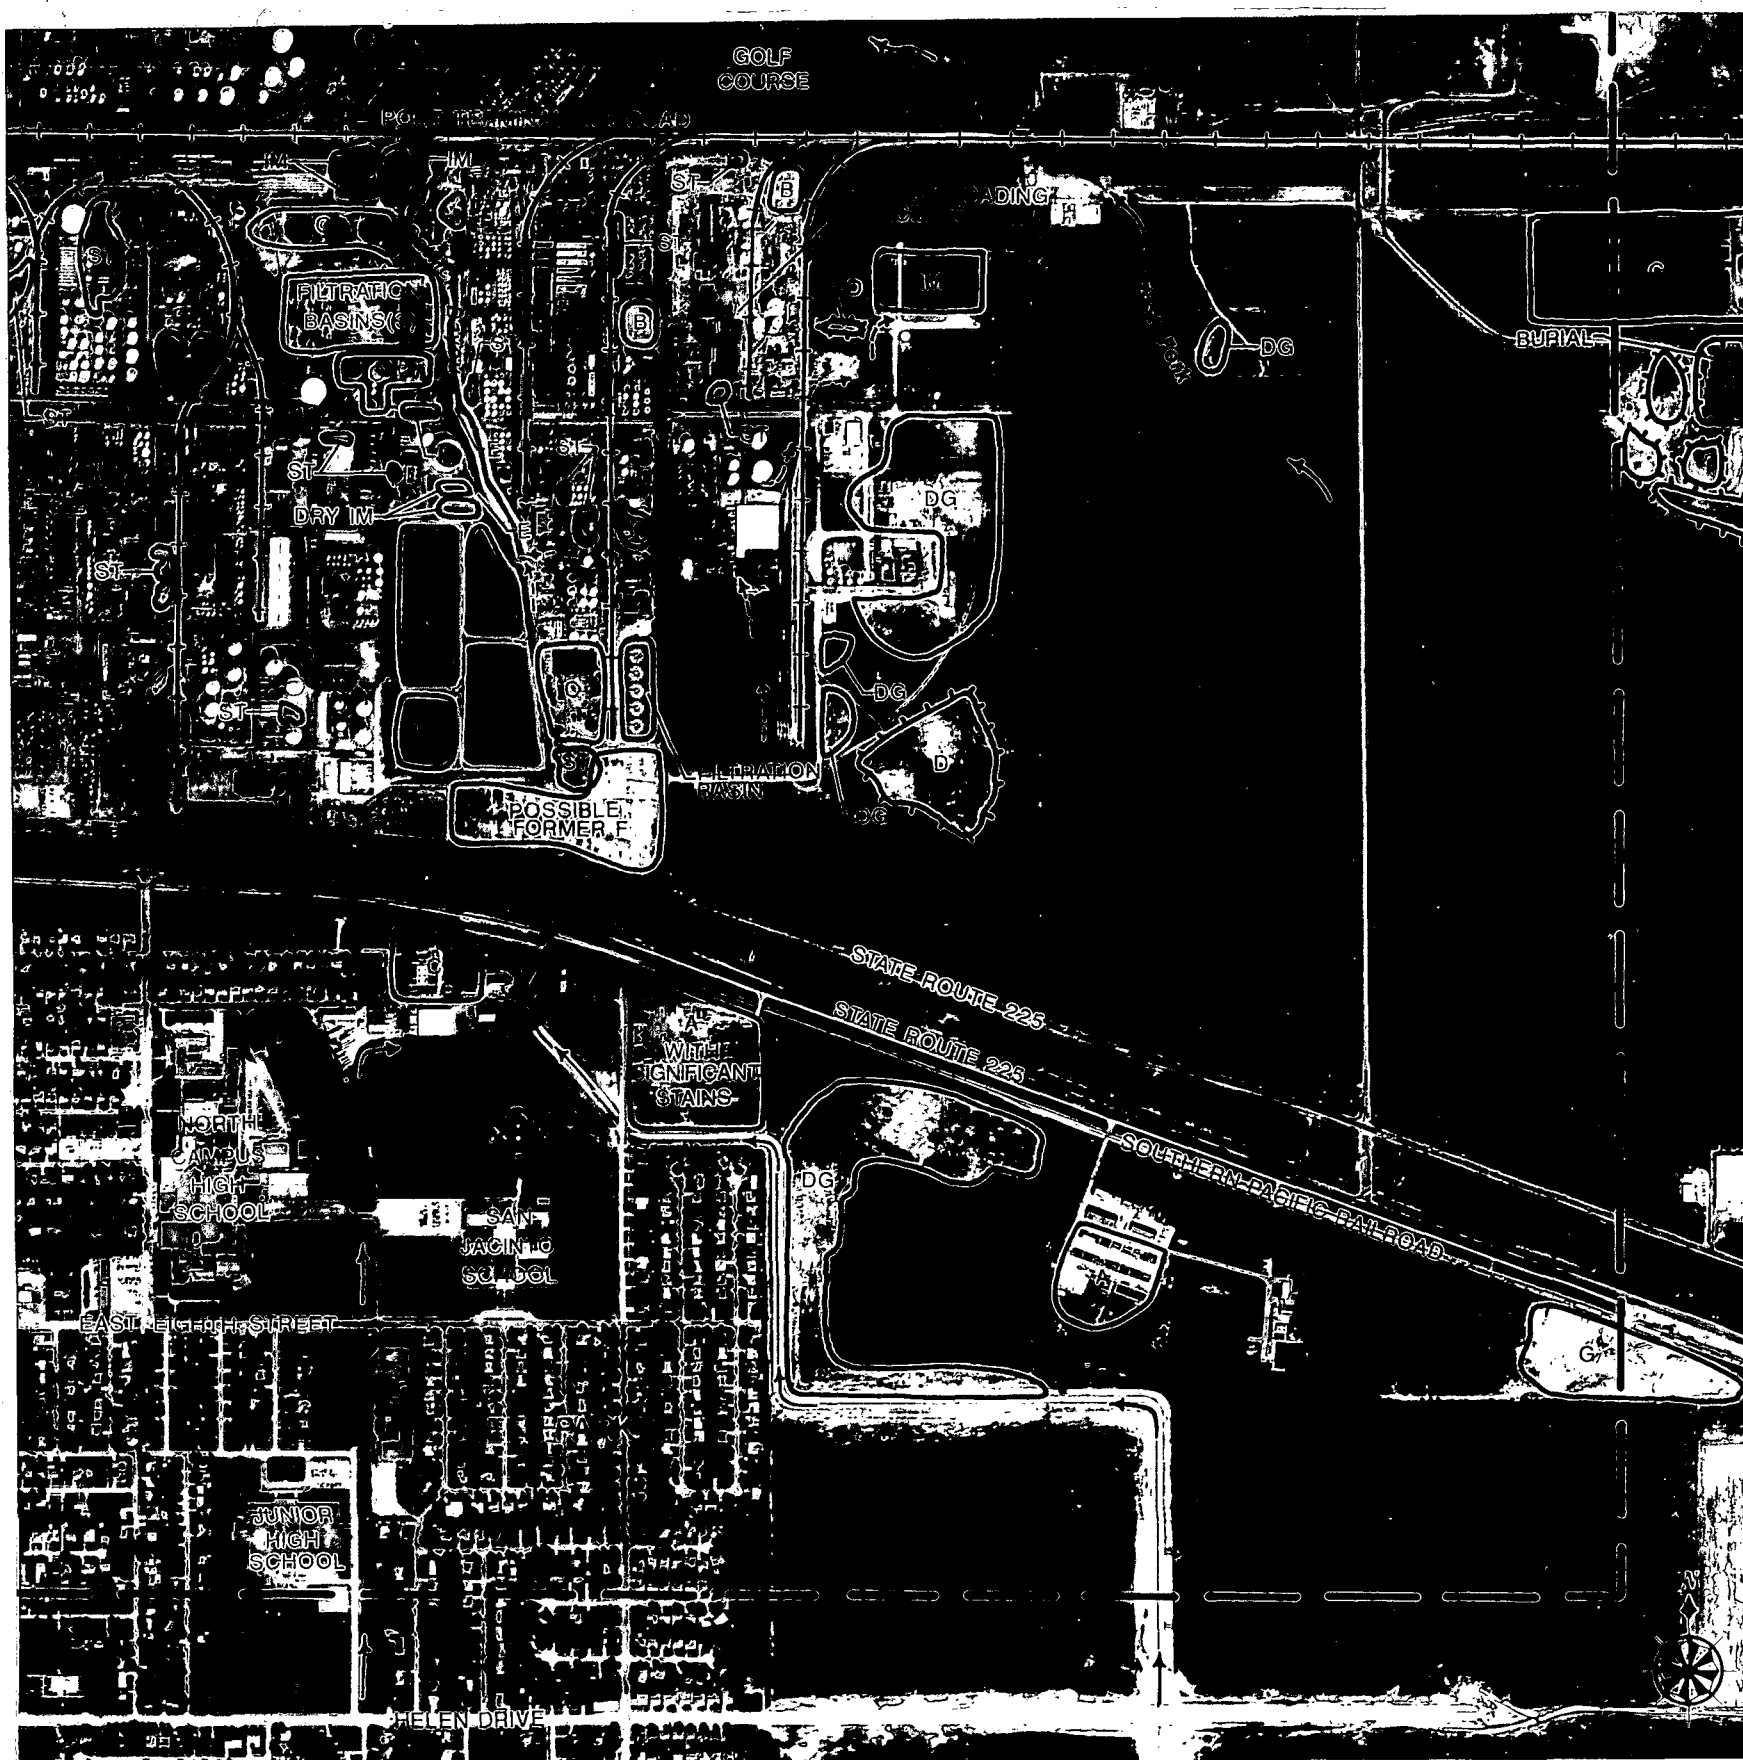
Figure 6. Shell Chemical-Deer Park Manufacturing Complex, November 4, 1981.
Approximate scale 1:11,000.

This photo covers the southeast quadrant of the study area. In this area all the storage tanks are adequately contained. There are several areas of staining visible throughout the study area. Five areas of ground disturbances and 15 liquid impoundments have been noted. The northern part of the city of Deer Park is visible, and three schools are shown in relation to the site. A facility used for the loading of tanker trucks is located in the site. Some stains are visible at this facility. Burial activity is visible in the easternmost section of this photo, it appears that liquid waste is being disposed of in this area. Other significant features are described below.

Annotation	Description
A	These are two storage areas that contain various construction materials. Significant staining is noted within one of the areas.
B	These are two power substations.
C	These are five water treatment facilities located in the study area.
D	These are two areas of dumping and liquid waste is possibly being buried in the eastern area.
E	These are two areas of outfall going into Patrick Bayou.
F	This is a possible former waste disposal area.
G	This is a sand and gravel operation that is supported by the Southern Pacific Railroad with a railcar loading/unloading facility.

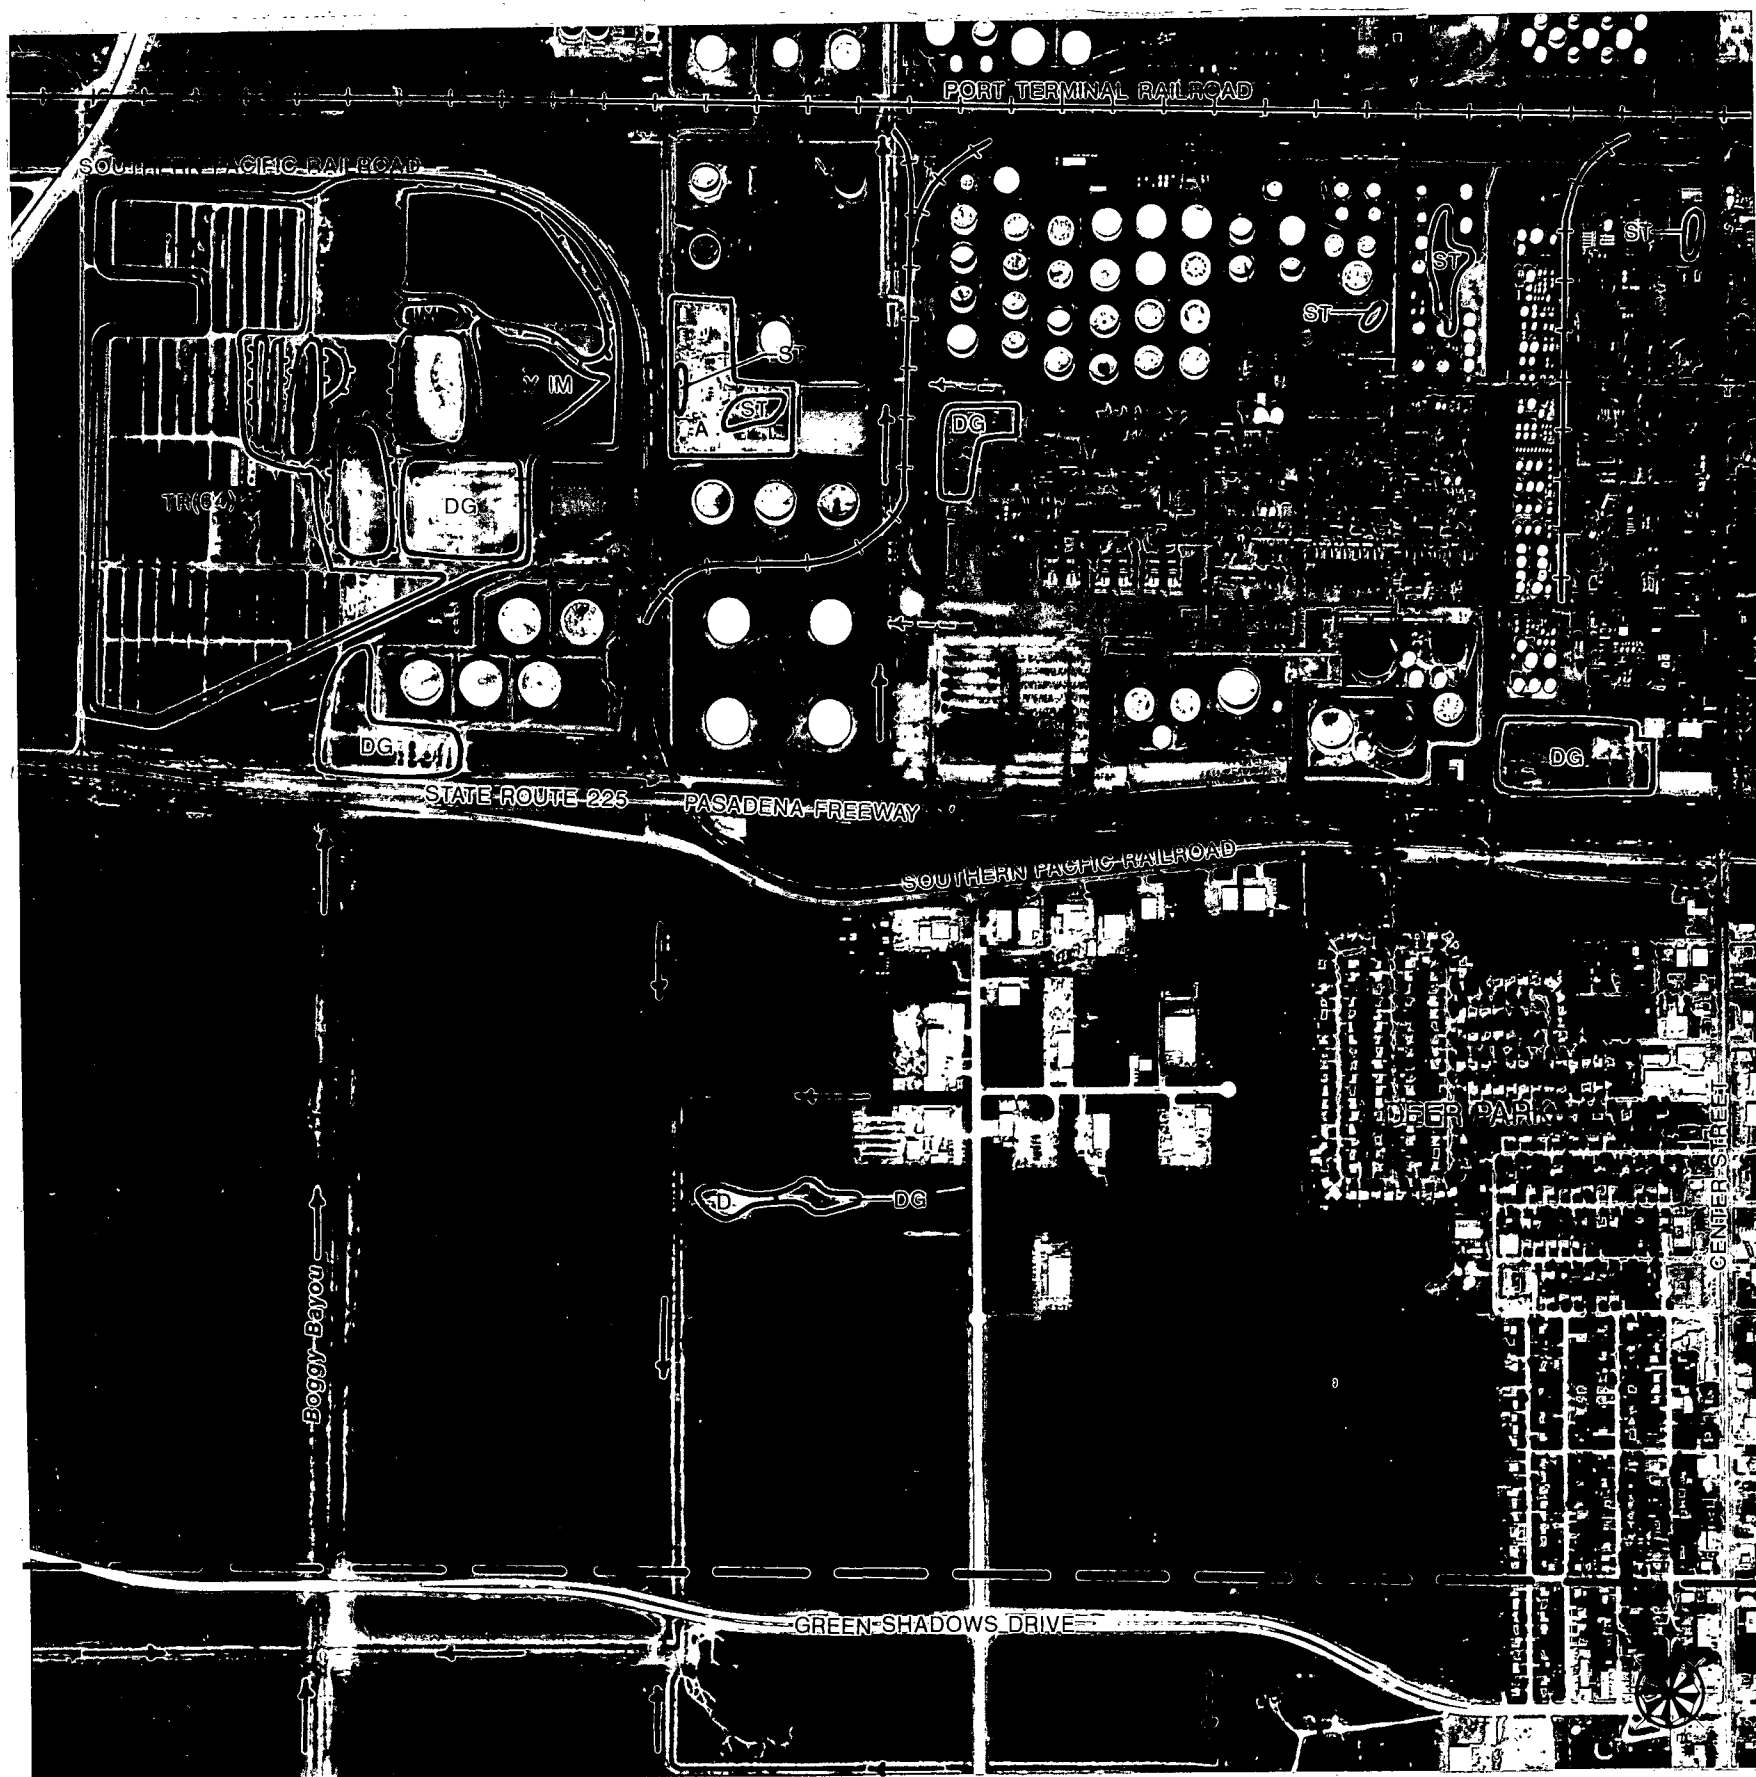
Figure 7. Shell Chemical-Deer Park Manufacturing Complex, November 4, 1981.
Approximate scale 1:11,000.

This photo covers the southwest quadrant of the study area. All storage tanks visible in this photo are adequately contained. There are areas of staining visible on this photo. Two liquid impoundments are located in this quadrant, and five areas of ground disturbances are also visible. Large areas of mounded materials are seen in this photo, all of which are located in a waste disposal area. Other significant features are described below.

Annotation	Description
A	One storage area containing various materials for the facility and some stains.
D	This is one small area of dumping.
F	This is a large waste disposal area with large areas of mounded materials, ground disturbances, 2 impoundments, and 64 trenches are located in this waste disposal area.

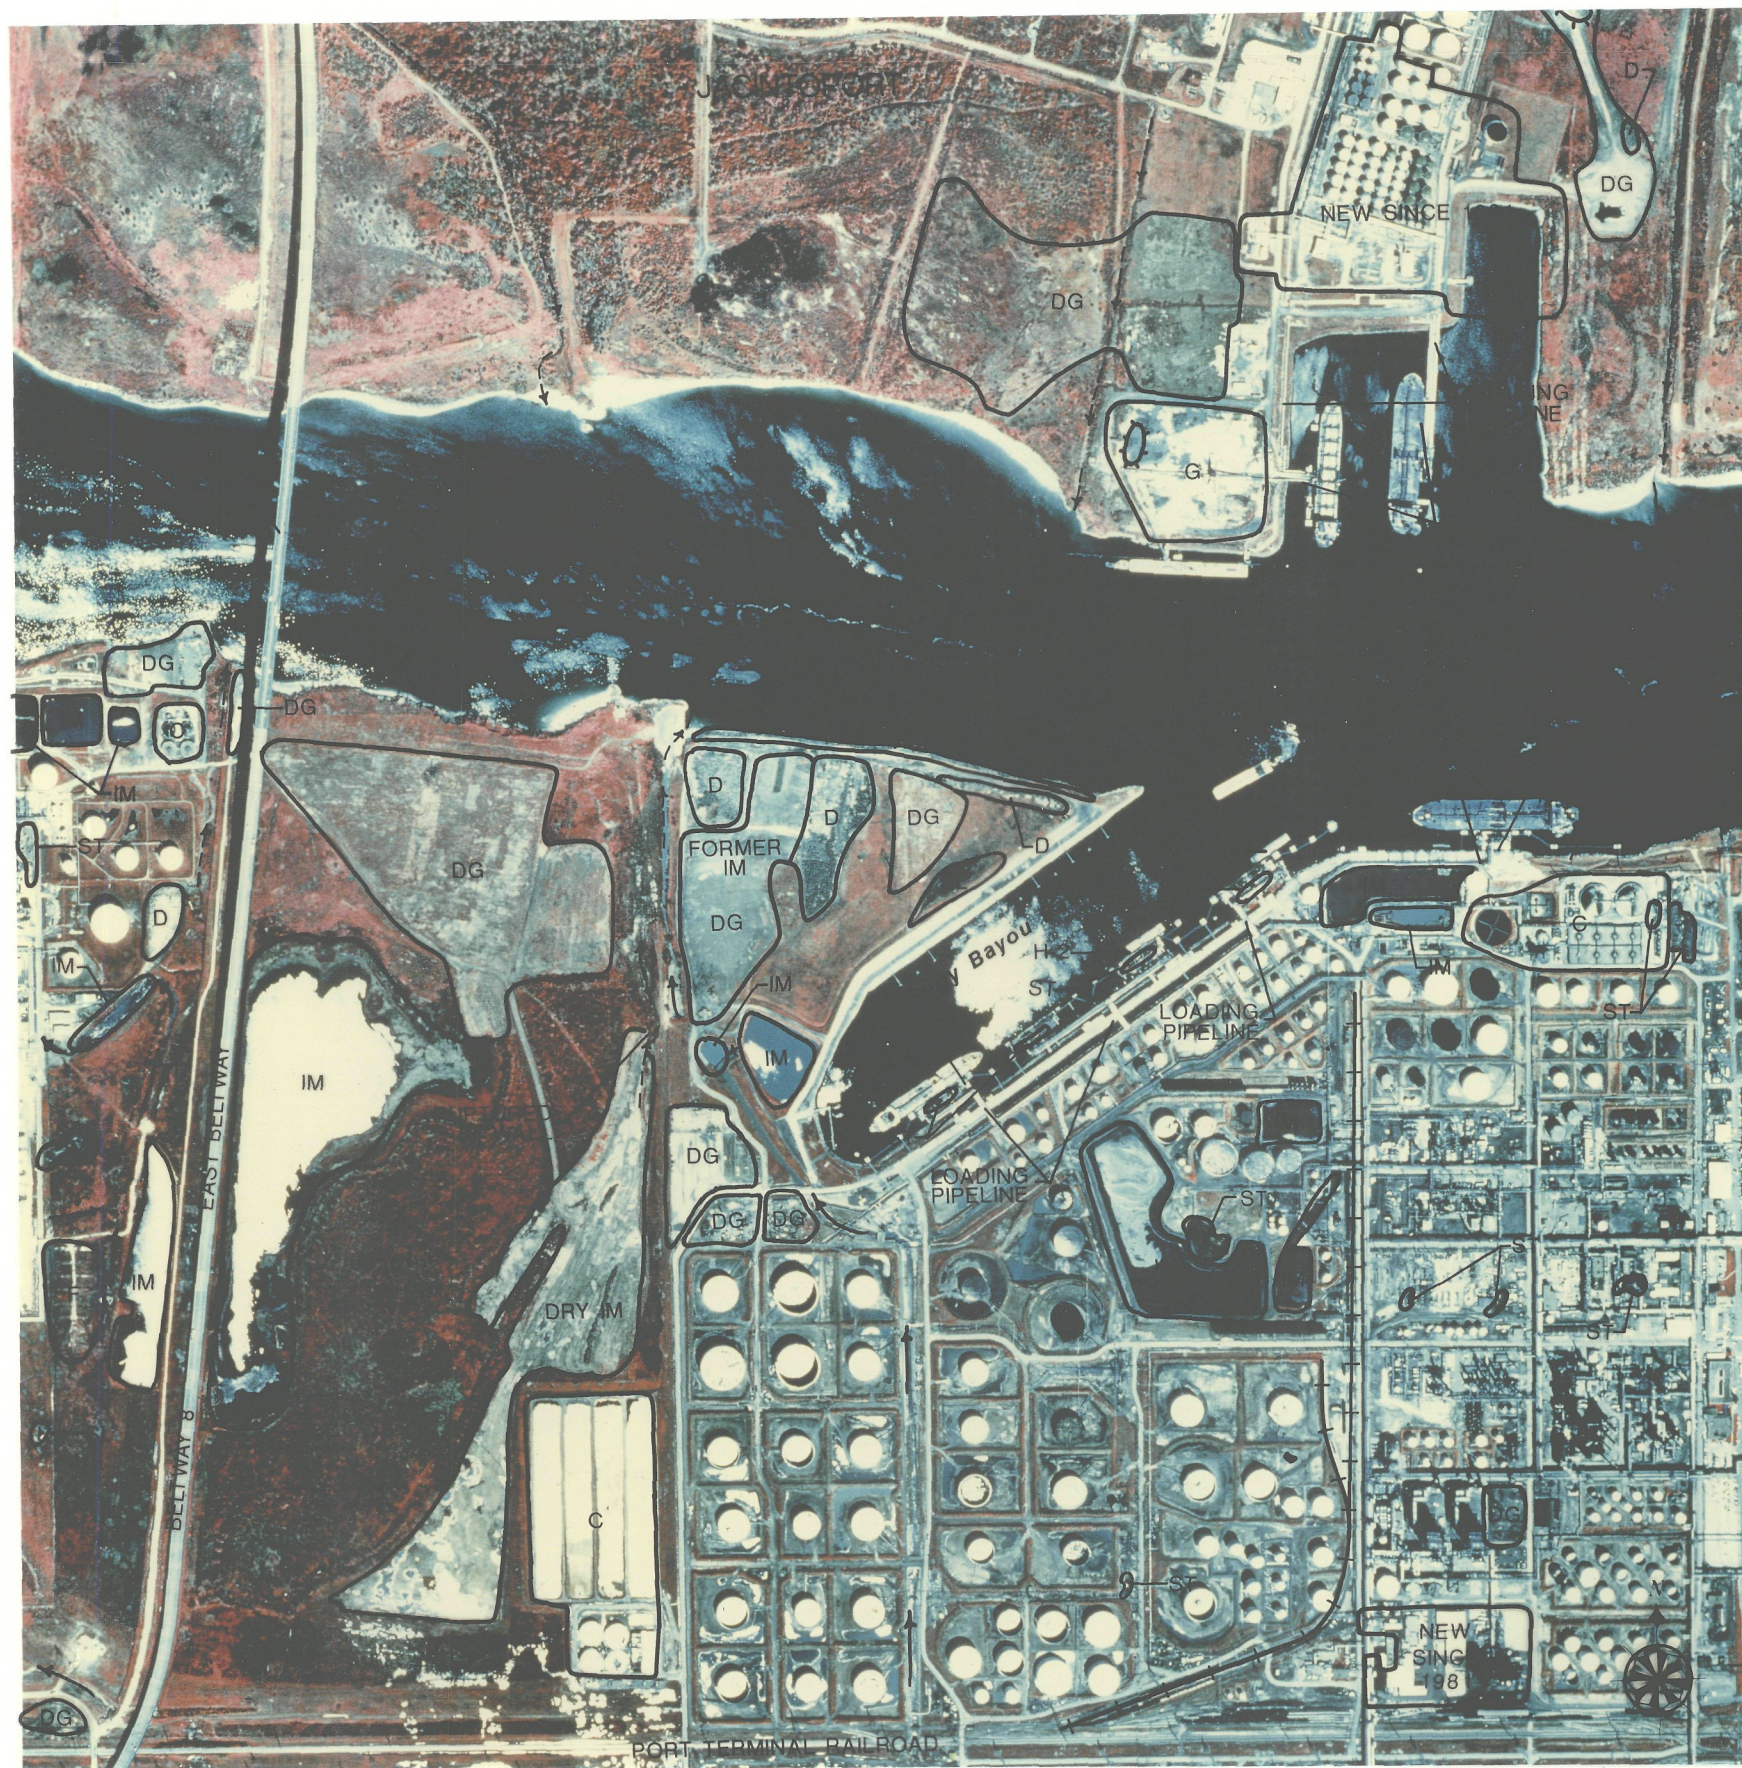
Figure 8. Shell Chemical-Deer Park Manufacturing Complex, March 23, 1989.
Approximate scale 1:10,800.

This color infrared photograph covers the northwest quadrant of the study area, and roughly corresponds to the 1981 photo in Figure 4. The storage tanks all appear to be adequately contained. Areas of staining have been noted in the site. There are 14 liquid impoundments located on this area. Thirteen areas of ground disturbances are also noted. The East Beltway 8 road construction has been completed since 1981. An area of mounded material is located in the ship loading facility on the north side of Buffalo Bayou. The northern wall of the large dry impoundment, southwest of Boggy Bayou Basin, has been breached. Spillage from this impoundment was able to reach Buffalo Bayou. Two areas of new construction have been added since 1981 to the site. Other significant features are described below.

Annotation	Description
C	Three water treatment facilities are visible in this quadrant.
D	These are six areas of dumping. The dumping to the west of the Boggy Bayou Basin is especially significant.
E	These are four liquid outfalls going into Buffalo Bayou.
F	This is a possible waste disposal area.
G	This is a sand and gravel operation.
H-2	This ship loading/unloading facility handles petroleum coke, crude oil, petroleum products and chemicals.
H-3	This ship loading/unloading facility handles petroleum coke, crude oil, petroleum products, chemicals, vegetable oils, tallow, animal fats, sand, gravel, stone, cement, phosphate rock, and aragonite.
